# Manhole Inspection Summary

Manhole # S29EE\_001MH

Insp Date: **4/22/09 2:26 PM**

**Location** Address: **500 W LAFAYETTE AVE**

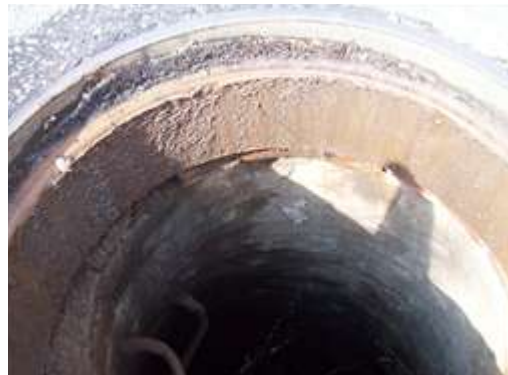
Defect 3

Count: **5** Missing: **0** ☒ **Corroded**

CORRODED STEPS

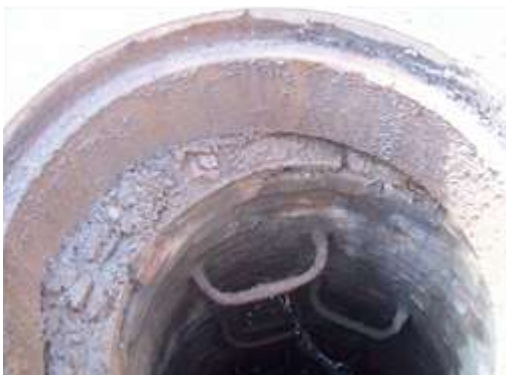
Defect 2

Condition: ☐ Sound ☐ Cracked ☐ Root Intrusion ☒ **Loose Brick** ☒ **Deteriorated**

CHIMNEY LOOSE BRICKS

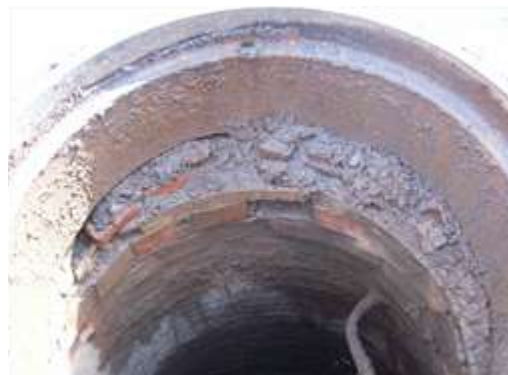
Defect 1

Offset: **4** (in.)

FRAME OFFSET AND CHIMNEY  
DETERIORATED

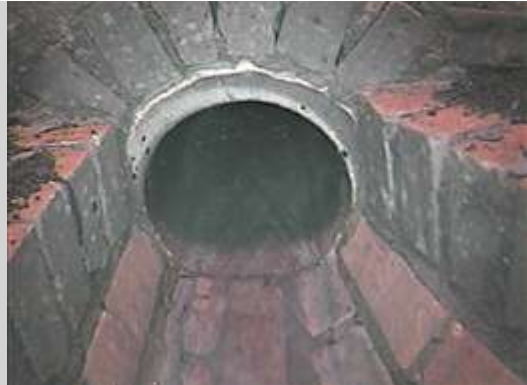
12 O'Clock Outflow

8 in. Circular Gravity Sewer  
Pipe Out @ 12 O'Clock

Pipe Height: (in.) Direct  
Pipe Material: **Clay** ☐ Pipe Lined  
Invert Depth: **9.49** (ft.) Flow Characteristics: **Slow**  
Deposits: ☒ None ☐ Mud ☐ Sludge ☐ Debris ☐ Grease  
Silt Depth: (in.) Deposits Extent:  
Infiltration: **None** Pipe Seal Cond: **Sound**

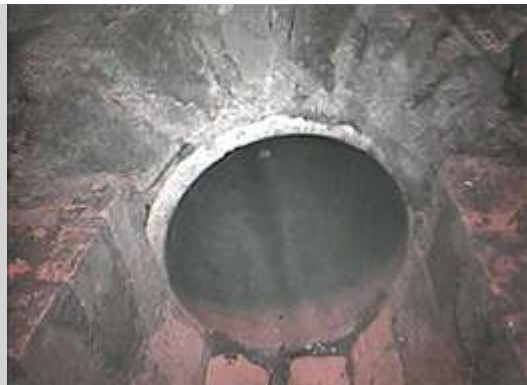
3 O'Clock Inflow

8 in. Circular Gravity Sewer  
Pipe In @ 3 O'Clock

Pipe Height: (in.) Direct  
Pipe Material: **Clay** ☐ Pipe Lined  
Invert Depth: **9.20** (ft.) Flow Characteristics: **Slow**  
Deposits: ☒ None ☐ Mud ☐ Sludge ☐ Debris ☐ Grease  
Silt Depth: (in.) Deposits Extent:  
Infiltration: **None** Pipe Seal Cond: **Sound**

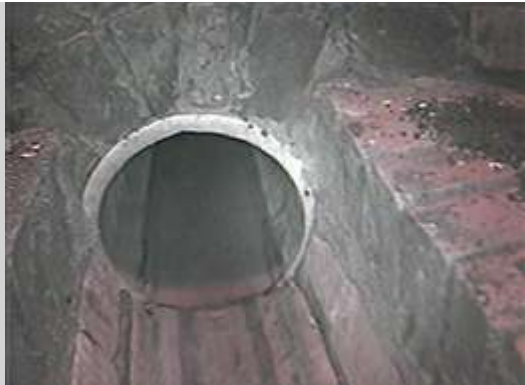
6 O'Clock Inflow

8 in. Circular Gravity Sewer

Pipe In @ 6 O'Clock

Infiltration: **None** Pipe Seal Cond: **Sound**
